STEAM BOILER EXPLOSIONS,

EDWARD BINDON MARTEN,

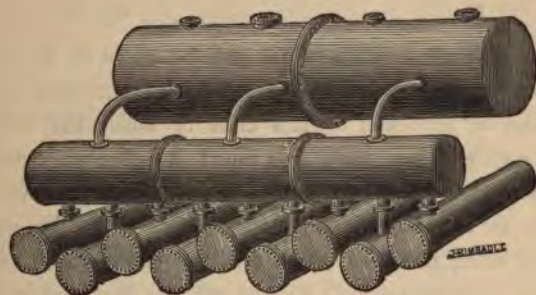
Fig. 10.

and boilers of this construction are still to be found in use at some of the older works at the present day. As the outside shell and front plate are $1\frac{1}{2}$ inch thick and are not exposed to any wear at all, these boilers are sufficiently strong. A duplicate front plate with set of tubes attached is always kept on hand in case of need. Another form of cast-iron boiler is shown in Fig. 9., made in several parts put together with flange joints, with an internal fireplace and flue also made of cast iron. When cast iron was used for the parts exposed to the fire in boilers intended for high pressure, it was sometimes employed in the form of tubes of small diameter and proportionately thinner; as in Woolf's boiler, so much spoken of in the evidence before the parliamentary committee of 1817. This boiler, shown in Fig. 10., consisted of nine cast-

iron pipes, about 1 foot diameter and 9 feet long, set in brickwork

so that the flame played all round them. These small tubes were connected with another of larger size placed transversely above them, forming a steam receiver, and this again with a still larger one, which formed a steam chamber. No details of any explosions of the three last mentioned boilers have been obtained; but it is known that the cast iron was found a most treacherous material, especially when exposed to the action of the fire; and that the effect of explosion was very disastrous, because the boiler burst at once into many pieces, each of which was driven out with great velocity, and the danger was not mitigated by the circumstance of large masses holding together, as is found to be the case with wrought-iron boilers when exploded.

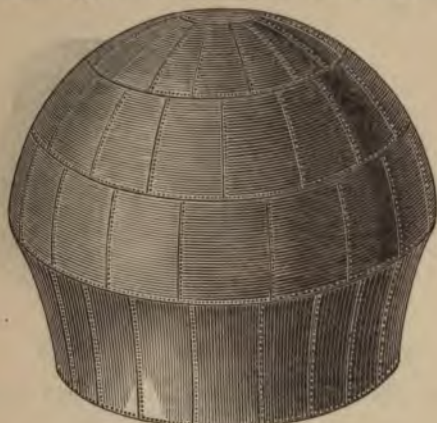
Fig. 18.

and 18, which represent the forms known so well in the

Staffordshire district as the common Balloon or Haystack boiler. Many of these have been made of very great size, measuring as much as 20 feet diameter, and containing so much water and steam as to be most formidable magazines for explosion. Perhaps no form of boiler has exploded more than this, partly because of the great number that have been used, but chiefly because of the inherent weakness of the shape. The records however have not been obtained of the great majority of these explosions, because they seldom caused sufficient damage or loss of life to attract much attention, as these boilers generally worked in isolated positions at collieries. The bottom is only prevented from blowing down into the fireplace by numerous stays from the top, and the angle iron round the bottom of the sides is much tried by the constant springing of the plates under every alternation of pressure; and the weakness thus occasioned is increased by the angle resting on the brickwork and being exposed to corrosion. The effect of this continued alternation of strain is well shown by the elastic model exhibited.

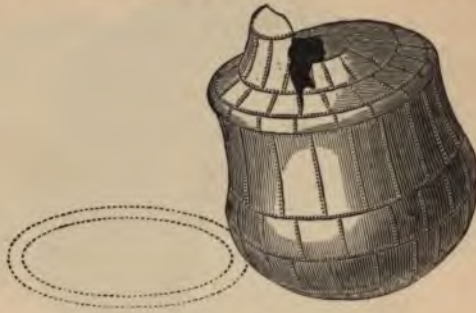
in 1862, which is shown in Fig. 19. As the force of the

explosion was only slight, the effect of the bottom giving way, and the consequent rolling over caused by the reaction of the issuing steam and water, is clearly seen. Another example that occurred at Wednesbury in 1862 is shown in Fig. 20, where the explosion was

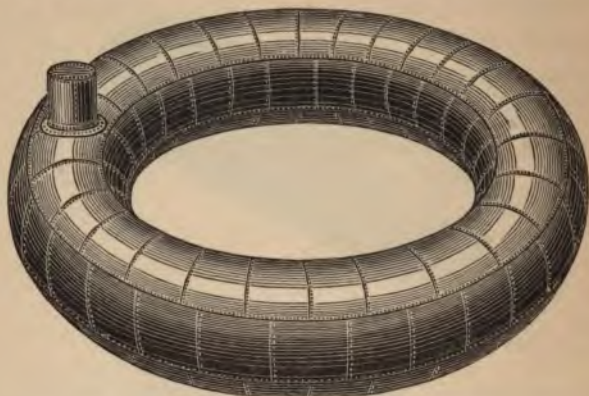
Fig. 26.

forming a Ring or Annular boiler. This boiler is shown in Fig. 26,

and is 5 feet diameter with 25 feet external diameter of the ring, or a mean length of about 63 feet ; it has been found to work well for some years, although exposed to the heat of six puddling furnaces.

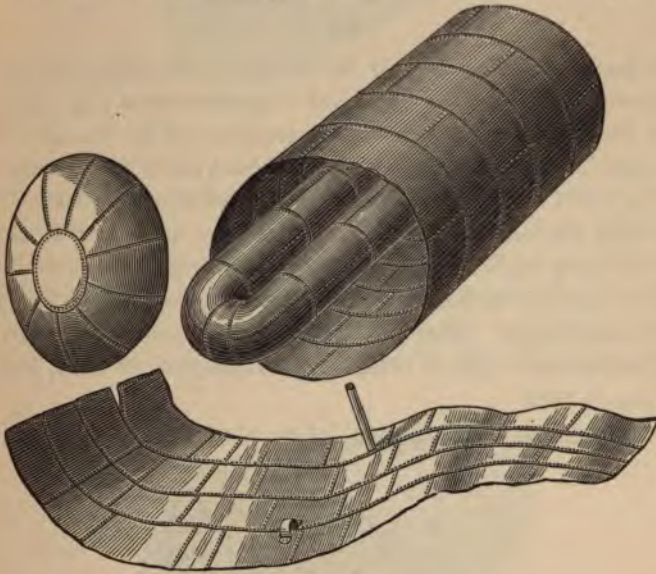
Fig. 36.

Explosions of these boilers have sometimes taken place by collapse of the tubes, but much more generally by the failure of the shell over the fire, as shown in the sketch Fig. 36,

representing an explosion that occurred at Wolverhampton in 1865, in which the first rent took place in a seam over the fire where frequent repair had led to a considerable length of longitudinal seam being in one continuous line. The four plates over the fire parted and opened out until they had ripped two seams completely

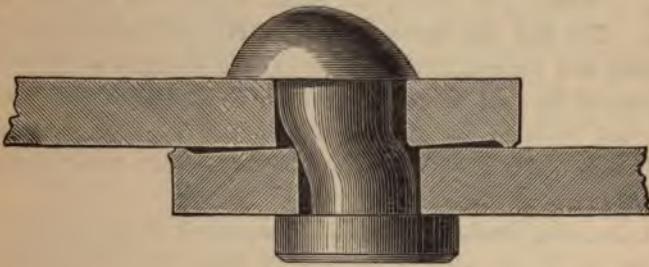
made, the errors have to be partially rectified by using the drift in the holes to an unwarrantable extent, and then using imperfect rivets to fill up the holes that do not correspond with each other; and the mischief is too frequently increased afterwards by excessive caulking, in the endeavour to stop the leaking which is sure to show itself. In this way a boiler is often exposed to most unequal internal strain between its several parts before it is set to work at all; and when the heat is applied to it, the mere expansion causes undue contortion, and leads to seam rips, and ultimately to disaster. Several specimens of faulty rivetting and caulking were exhibited to the meeting, and a sketch of one of them is shown in Fig. 52.

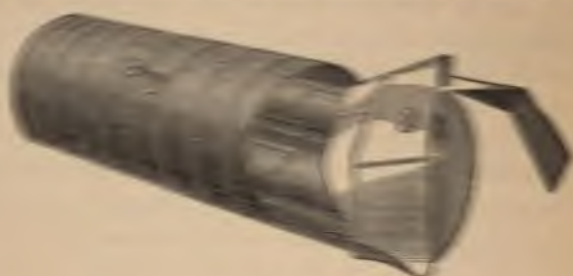
Fig. 65.

Explosions have also taken place from general corrosion of the surface of the boilers in the flues. A new boiler which was set on sidewalls built upon a foundation of porous rock was found to have become corroded all along the bottom in less than two years, owing to the dampness which rose from the foundations causing a constant presence of vapour. The corrosion was peculiar, and more like that found on old iron left for a long time in a damp place; for the iron plate fell to pieces when touched, and large flakes could be raised from the surface, and the greater part of the thickness of the plate could be removed with the fingers. Somewhat similar corrosion had taken place in a boiler which exploded at Loughborough in 1863; the bottom of the shell became rent at the corroded part, and as the fracture continued spirally round the boiler several times, nearly all the shell was peeled off in the curious manner shown in Fig. 64. The explosion shown in Fig. 65, which occurred at Leeds in

1866, also arose from corrosion of the bottom of the boiler.

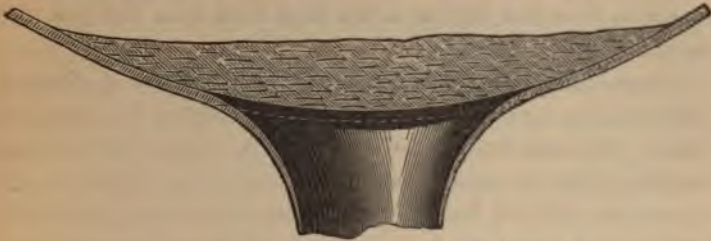
transverse section, Fig. 72. In this case the scurf had filled

up the circle of the boiler to a depth of 3 inches at the bottom, as shown in the drawing, and was of a very hard description; and the boiler plate was bent out in a gradual curve, and thinned to about $\frac{1}{16}$ inch, the original thickness being $\frac{1}{2}$ inch.

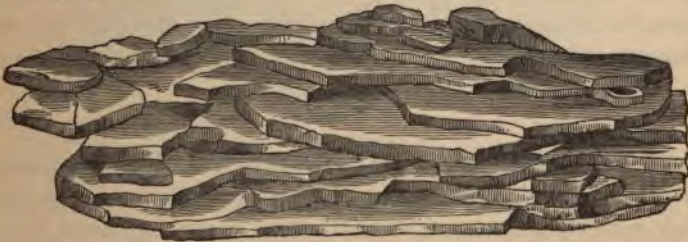
Fig. 73

The whole bottom of a boiler is sometimes injured, and the plates buckled and the seams sprung, from the accumulation of mud. One case may be mentioned where the water was very full of mud, and the boilers were worked day and night during the week but stopped for several hours on Sunday, during which time the deposit of mud was so thick that it did not get thoroughly disengaged again from the bottom when the boiler was set to work, but hardened into a mass. Although many of these pockets and injuries to the plates may occur without serious damage, they sometimes cause that first rent which destroys the equilibrium of the structure and leads to explosion. Some of the specimens of scurf exhibited to the Meeting show that their thickness is made up of small chips, carelessly left after cleaning or fallen from the sides of the boiler, as seen in Fig. 73, or from cotton waste or other matter left in the boiler

and forming a nucleus for the scurf to accumulate upon. Other specimens show that foreign matter must have been put into the boiler to stop leaking.

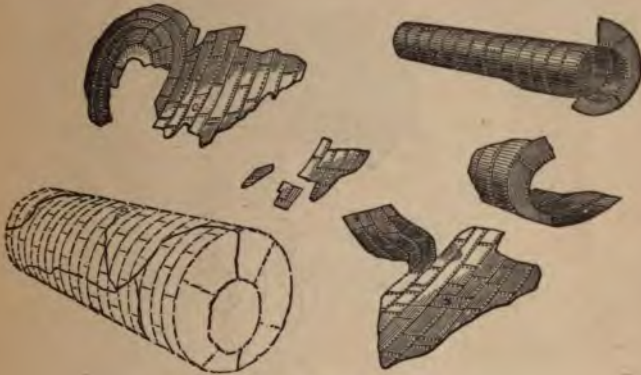
Fig. 23.

The greatest number of explosions and the greatest loss of life and personal injury have been in the case of Cornish and Lancashire boilers, or others with internal flues. In the county of Cornwall itself there have been many explosions, as often from the rupture of the shell, Fig. 23, No. 58, 1869, as from the collapse of the tube,

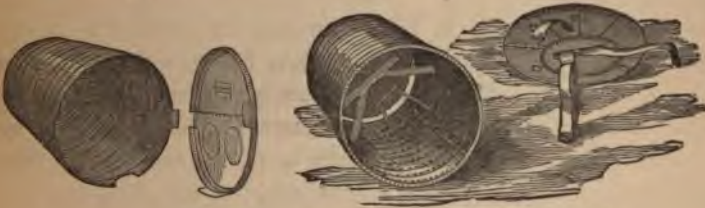
Fig. 33.

Fig. 33, No. 47, 1869, where two tubes were taken out, and Fig. 34, No. 42, 1867, where one tube was taken out. One of the most frequent and serious causes of loss of strength is the repairing of externally fired boilers. Not only are the patches sometimes

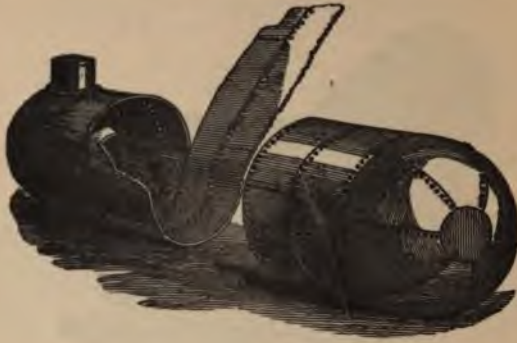
Fig. 5.

No. 9. Birmingham. (Fig. 5.) February 7th. 1 killed, 4 injured.

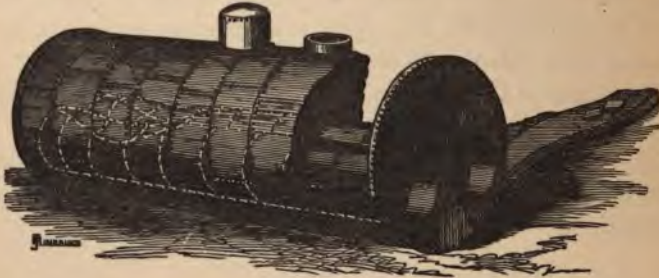
Fig. 32.

No. 69. *Manchester.* (*Fig. 32.*) *December 15th.* *5 injured.*

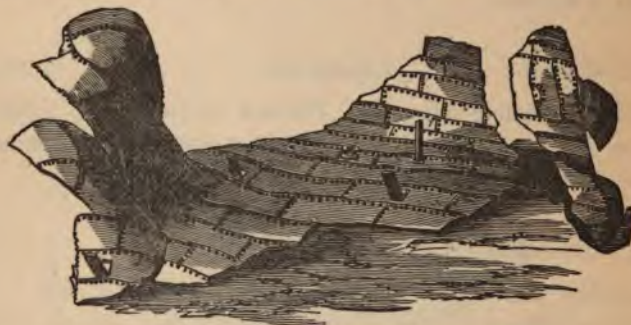
Fig. 3.

No. 10. *Sunderland.* (*Fig. 3.*) *January 26th.* *3 injured.*

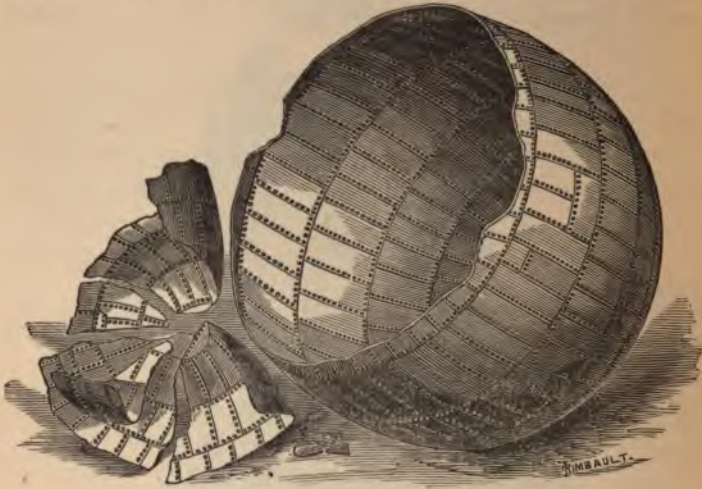
Fig. 15.

No. 25. *Dudley.* (Fig. 15.) July 10th. 1 killed, 2 injured.

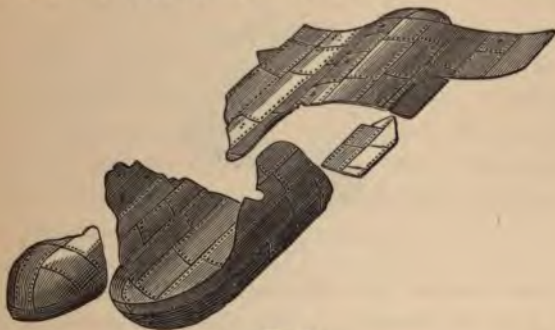
Fig. 1.

No. 1. *Newcastle.* (*Fig. 1.*) *January 13th.* *none injured.*

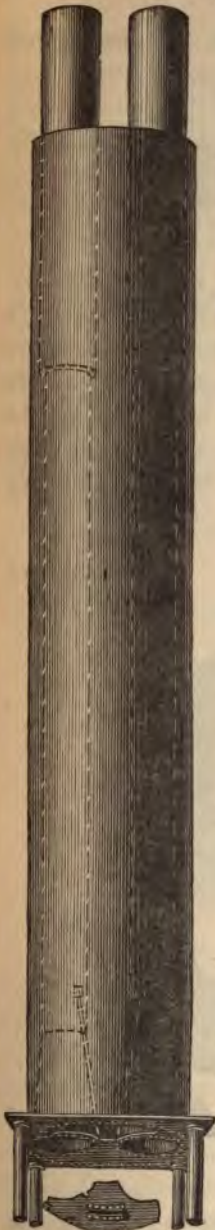
Fig. 17.

Two tube Cornish. The manlid was wrongly fixed outside with internal clamps. It was being screwed up tighter to stop leaking when the bolt broke, and the lid came off and allowed the contents of the boiler to escape.

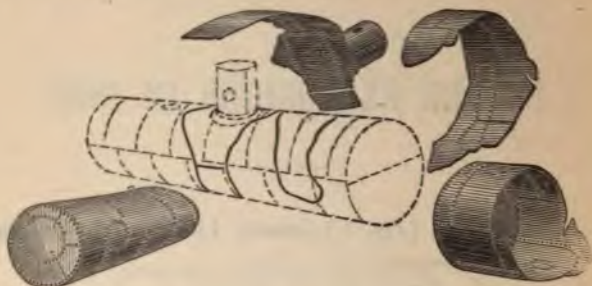
Fig. 3.

No. 3. Greatbridge. (Fig. 3.) January 26th. 1 killed, 1 injured.

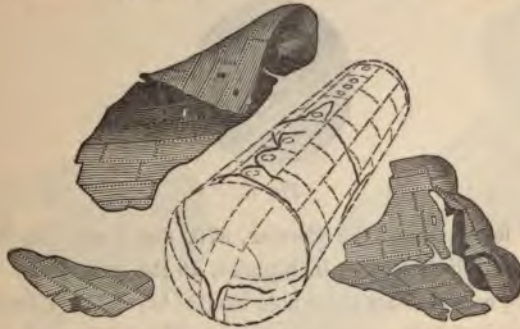
Fig. 5.

No. 5. Durham. (Fig 5.) February 2nd. 1 killed, 4 injured.

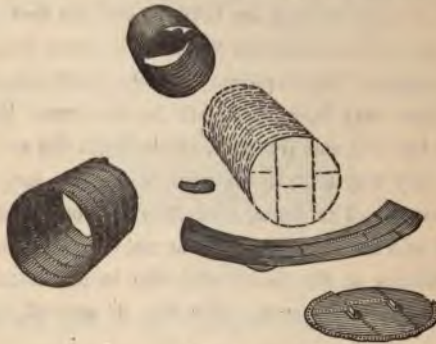
Fig. 16.

No. 21. South Wales. (Fig. 16.) May 31st. 5 killed, 4 injured.

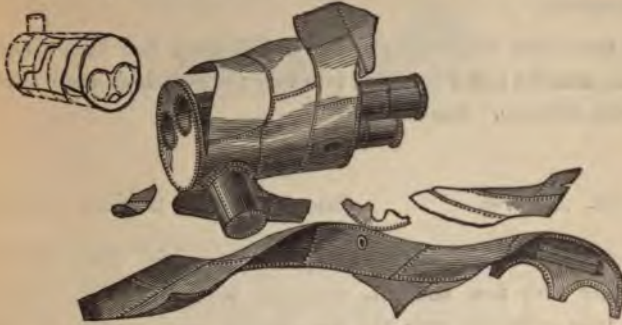
Fig. 17.

No. 22. Bingley. (Fig. 17.) June 9th. 15 killed, 33 injured.

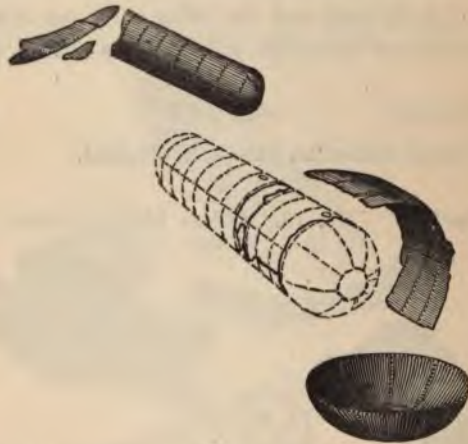
Fig. 19.

No. 26. *Nuneaton.* (Fig. 19.) July 5th. 3 injured.

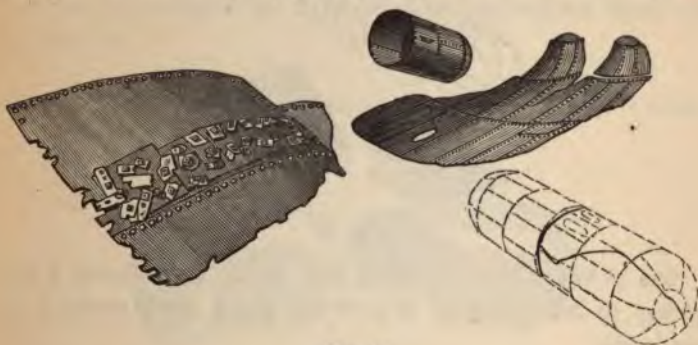
Fig. 21.

No. 29. *Kidderminster.* (Fig. 21.) *July 16th.* 1 killed, 4 injured.

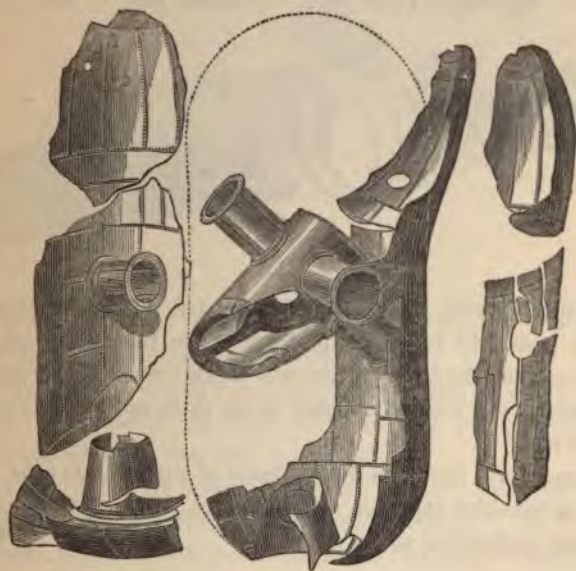
Fig. 42.

No. 53. Bilston. (Fig. 42.) December 3rd. 8 killed, 1 injured.

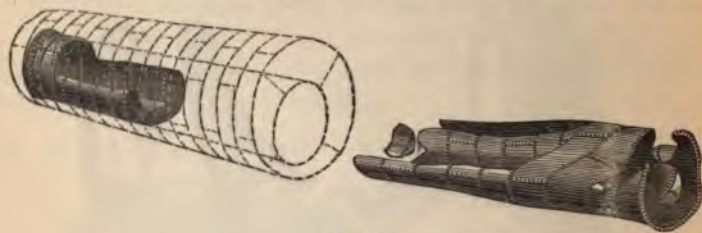
Fig. 43.

No. 54. Cornwall. (Fig. 43.) December 6th. none injured.

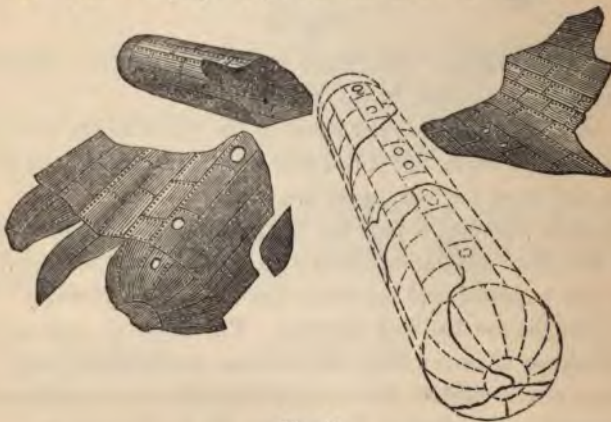
Fig. 47.

No. 59. *Durham.* (Fig. 47.) *December 29th.* 2 killed, 1 injured

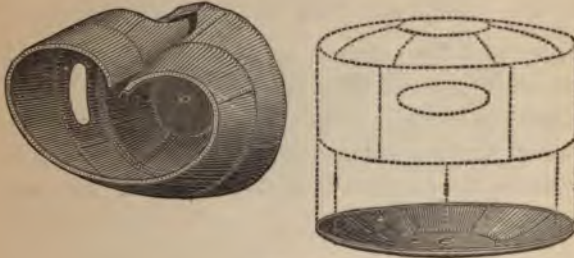
Fig. 5.

No. 5. Sheffield. (Fig. 5.) February 8th. 2 killed, 6 injured.

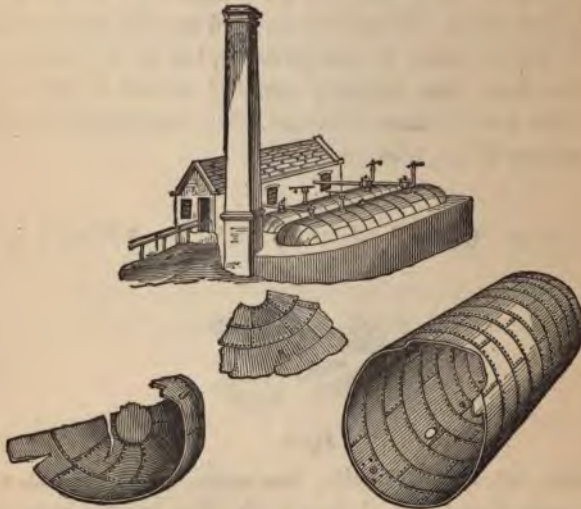
Fig. 8.

No. 8. *Walsall.* (Fig. 8.) *February 19th.* none injured.

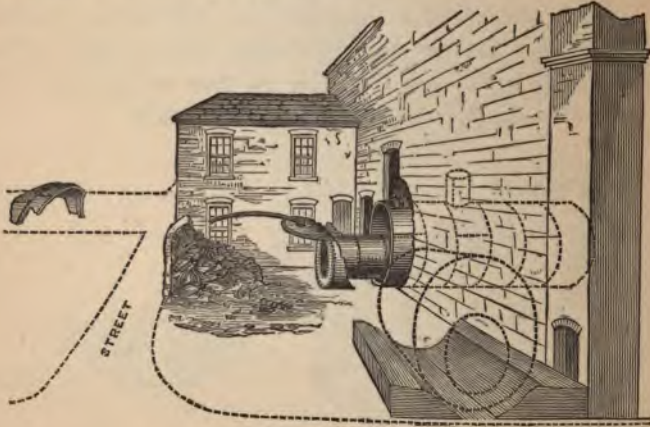
Fig. 12.

No. 12. *Portsmouth.* (Fig. 12.) *March 29th.* 3 killed, 1 injured.

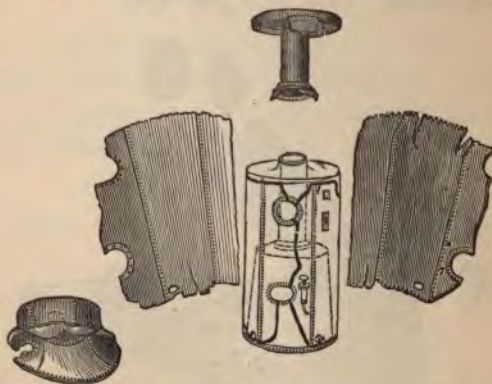
Fig. 27.

No. 31. *Glasgow.* (Fig. 27.) *June 17th.* none injured.

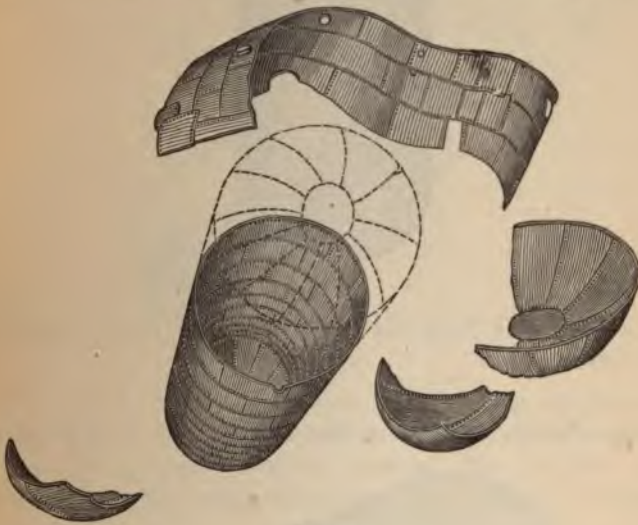
Fig. 28.

No. 32. Bilston. (Fig. 28.) June 21st. 2 killed, 6 injured.

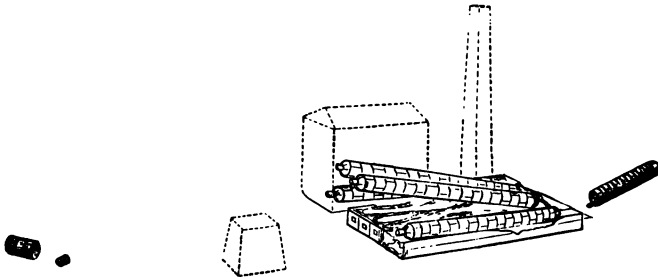
Fig. 12.

No. 22. Brigg. (Fig. 12.) March 17th. 1 killed, 1 injured.

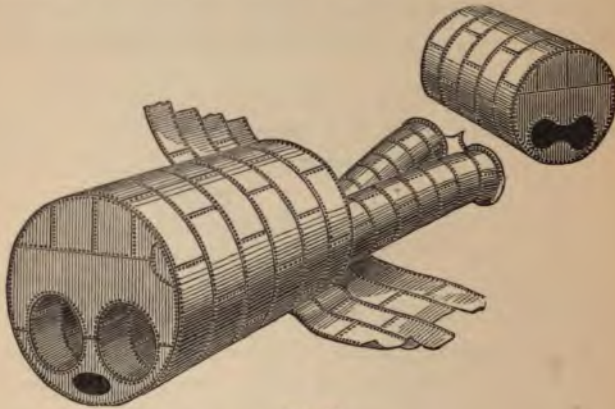
Fig. 13.

No. 23. *S. Wales.* (*Fig. 13.*) *March 18th.* *none injured.*

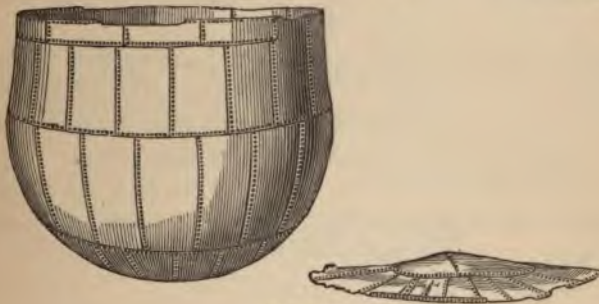
Fig. 18.

No. 31. Oakengates. (Fig. 18.) June 6th. none injured.

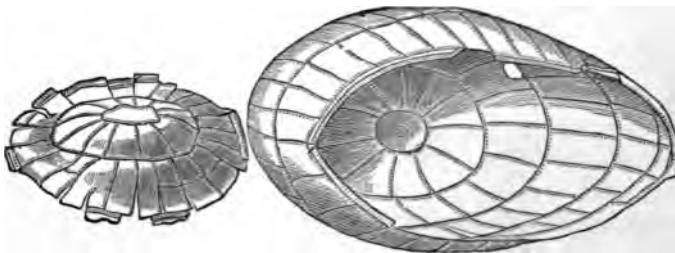
Fig. 38.

No. 65. Westbromwich. (Fig. 38.) December 28th. 1 injured.
